# Fortress Dömitz

*STRUCTURAL ELEMENT: SANDSTONE PORTAL*

Documentation of a Restoration and Repair Project

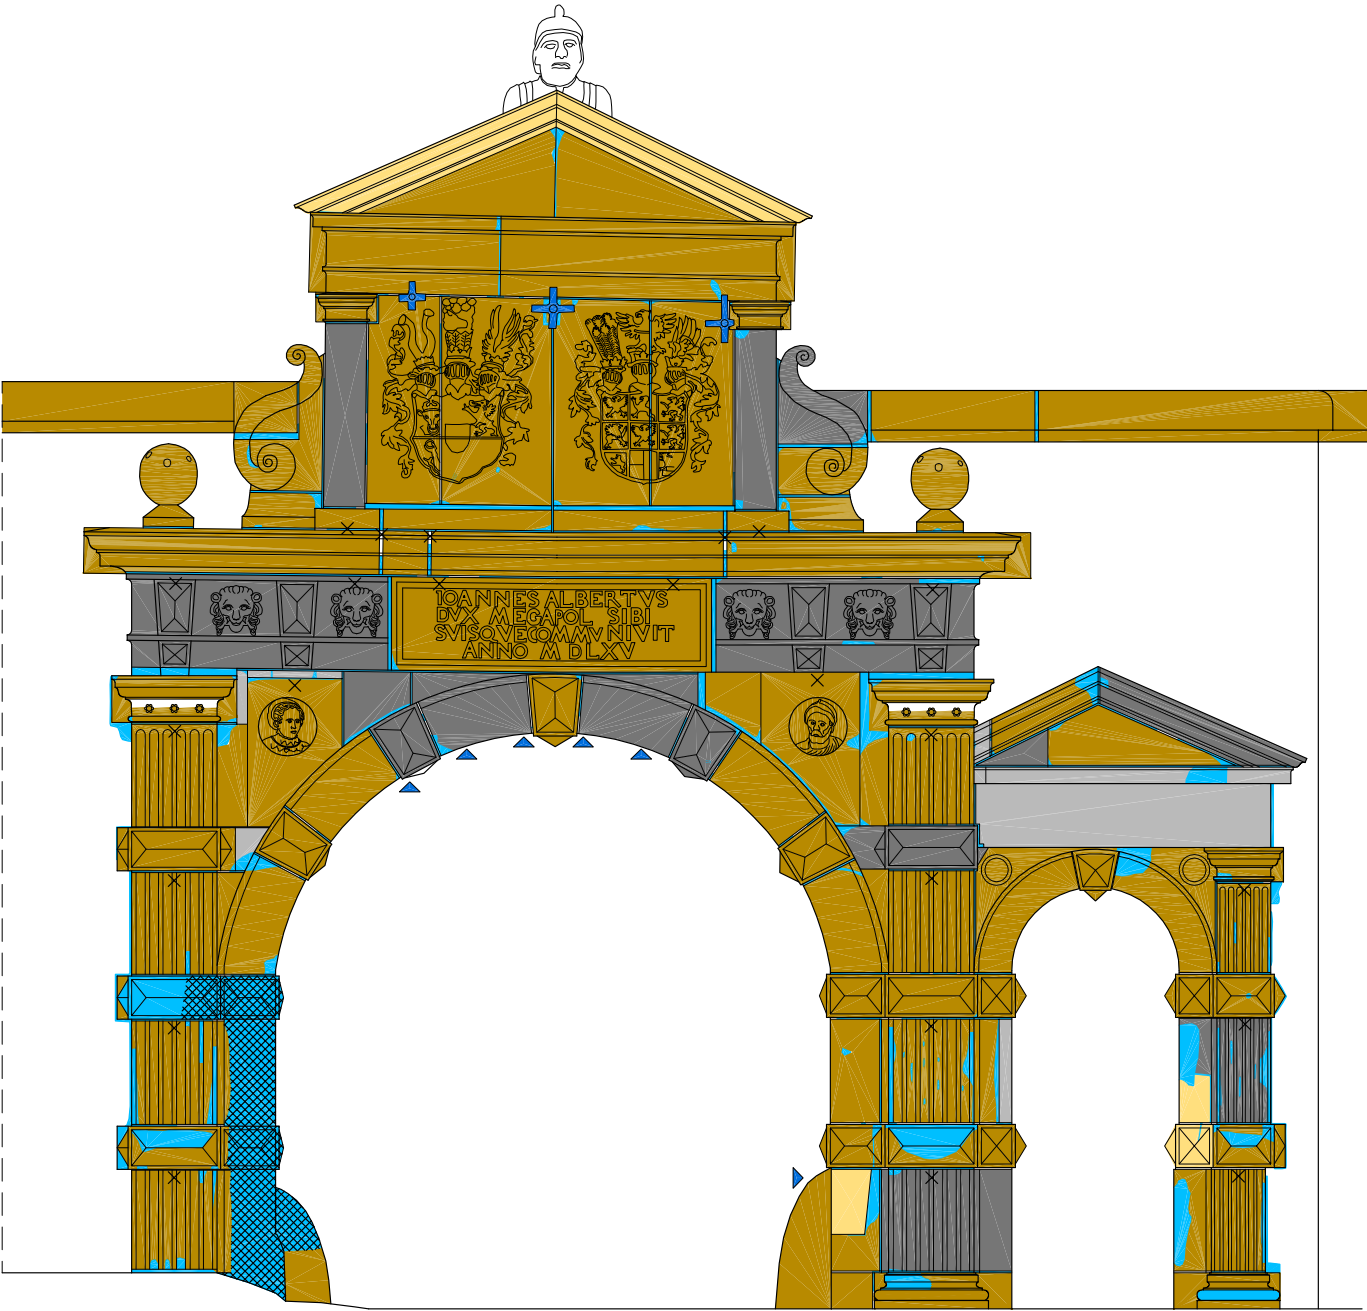
DÖMITZ FORTRESS  
SANDSTONE PORTAL  
MATERIAL MAPPING 2005

TYPE OF MAPPING		SITE	OBJECT	STRUCT. ELEMENT/AREA
MATERIAL MAPPING		DÖMITZ FORTRESS	SANDSTONE PORTAL	VIEWS
COLOUR	SYMBOL			
		COTTA SANDSTONE, GREY		
		COTTA SANDSTONE, YELLOW		
		POSTA SANDSTONE, YELLOW, BANDED		
		POSTA SANDSTONE, GREY, FOSSIL-CONTAINING		
		MORTAR ON BRICKWORK		
		REPAIR MORTAR		
		VISIBLE IRON ELEMENTS		
		DETECTED IRON ELEMENTS

The locations of the anchors were determined using a metal detector and recorded on the Material Mapping. The anchoring system for the lower portion of the portal was found to be relatively evenly distributed. Every masonry unit of the gateway jambs and the cornice above them is secured by at least one anchor.

The top section of the portal, however, is supported by only the three visible anchors, which were probably added during later restoration work. The degree of rusting was estimated visually by means of endoscopic analyses on two of the wrought-iron anchors. Although rust formation is visible and the entire top section of the portal appears distorted, the load-bearing capacity of the anchors was determined to be sufficient – owing in part to their generous dimensions.

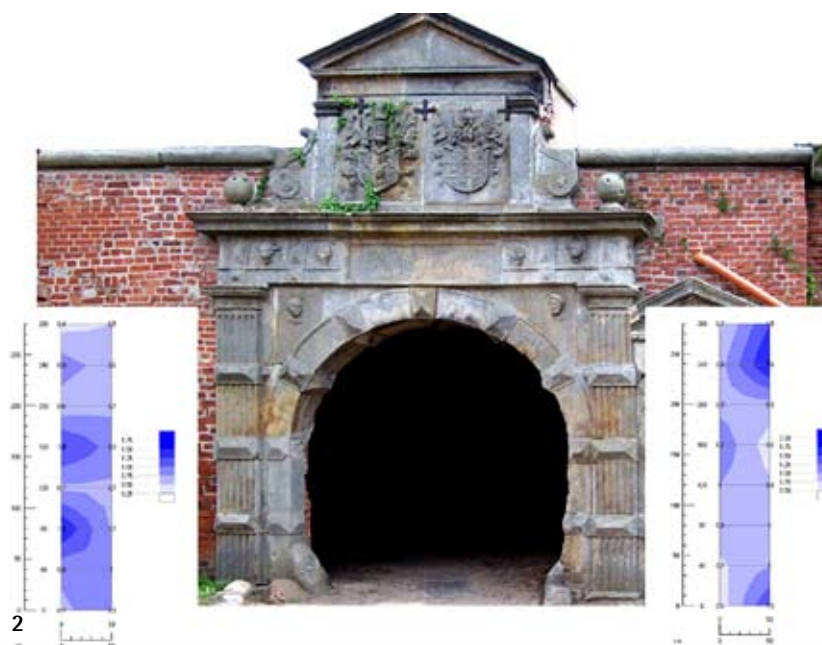
*Fig. 2 - Measured moisture content of the pilaster sandstone left and right of the gateway. The high values measured in the upper right section can be attributed to water run-off from the side pediment.*

Measurements taken on the sandstone elements above the archway and main cornice revealed increasing moisture values from top to bottom. The reason for this phenomenon was the penetration of rainwater into the structural elements from above.

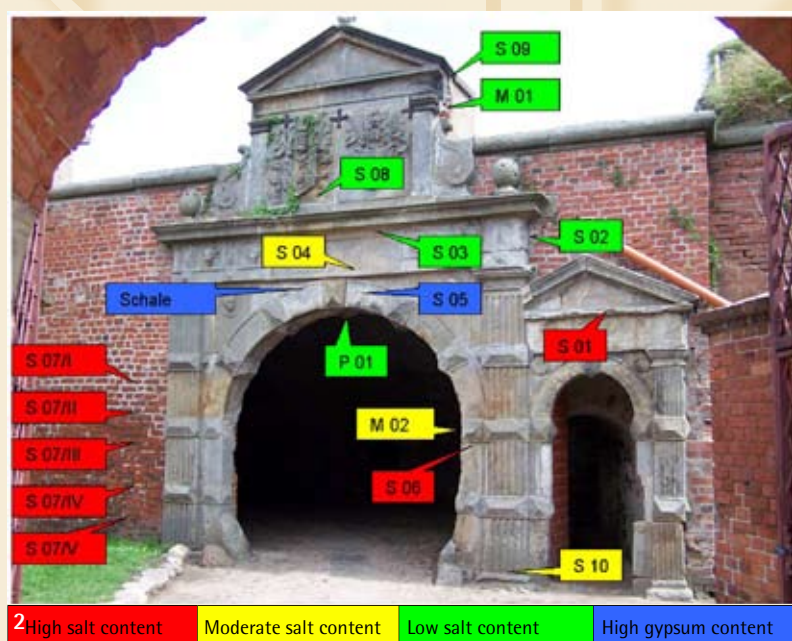
The salt analyses revealed that the salt content of the portal sandstone varies greatly. The area above the archway, for example, was found to have a salt content near zero, while a high content of structurally damaging salts was found in the jambs and pilasters owing to rising damp from the adjacent brickwork.

Fig. 2 – Mapping of the collected samples and their salt content

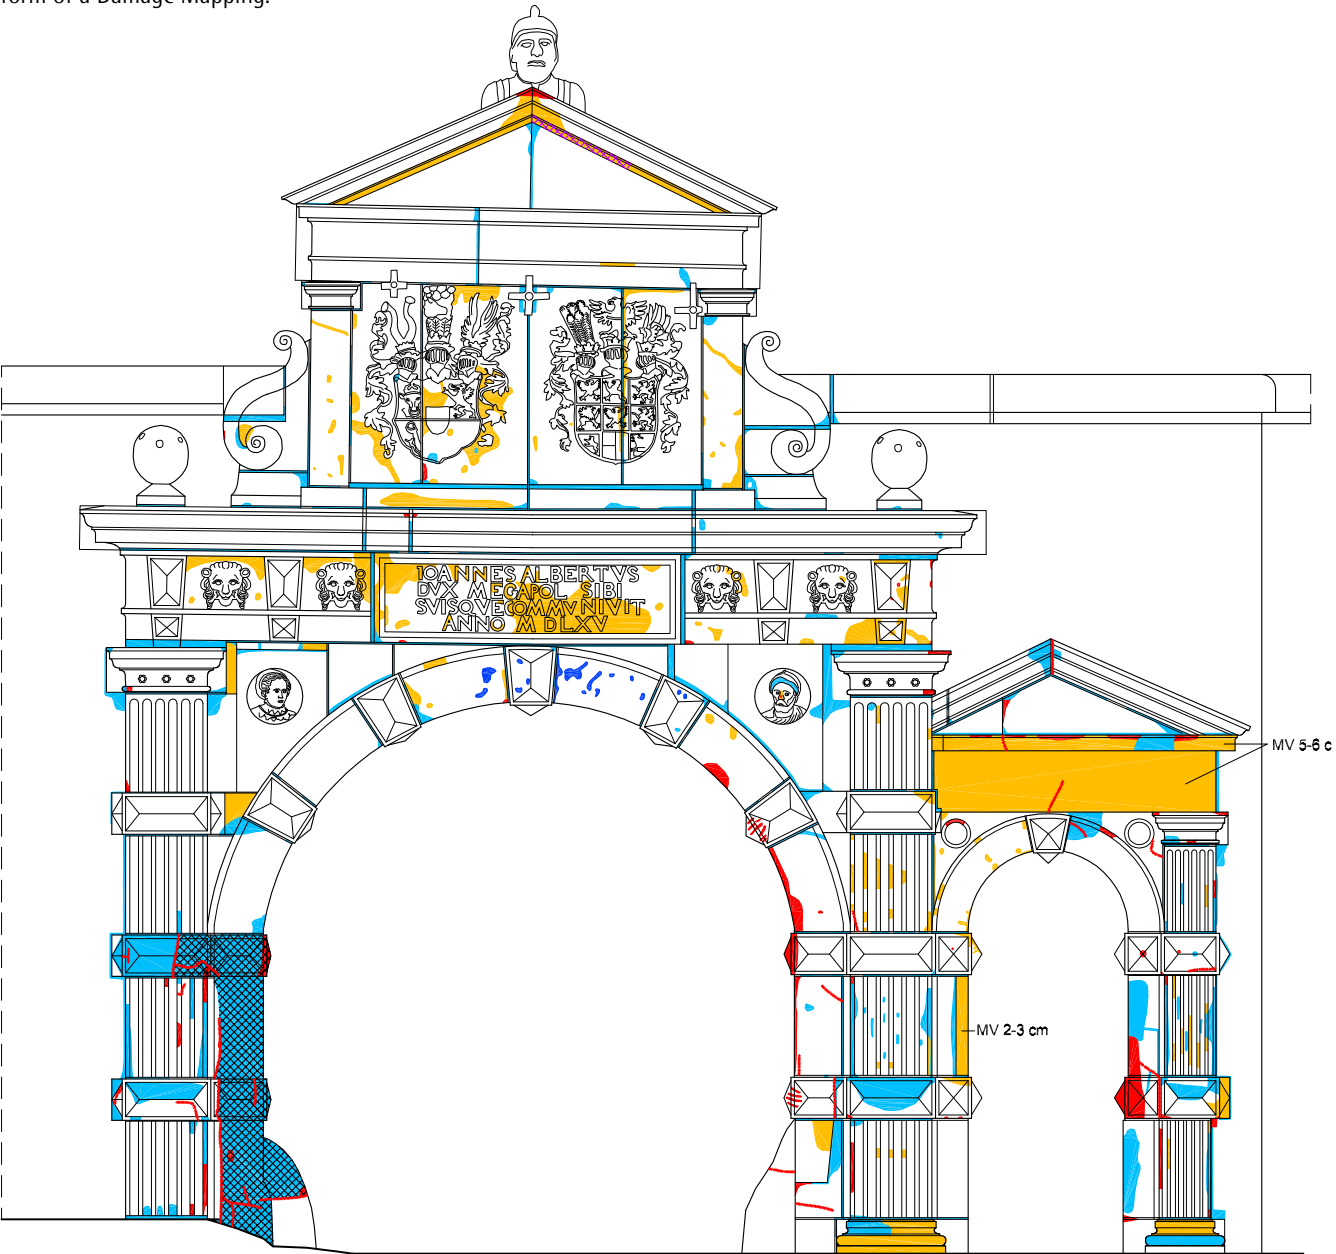
Below - Damage Mapping

Along with the damage closely associated with the moisture and salt content of the sandstone numerous other types of damage were observed during the preliminary investigation. All observed damage was documented in the form of a Damage Mapping.

TYPE OF MAPPING		SITE	OBJECT	STRUCT. ELEMENT/AREA
DAMAGE MAPPING		DÖMITZ FORTRESS	SANDSTONE PORTAL	VIEWS
COLOUR	SYMBOL			
		BREAK OUT / FLAWS		
		CRACKS		
		GRANULAR DISINTEGRATION		
		CONTOUR SCALING		
		CRUSTS		
		REPAIR MORTAR		
		MORTAR ON BRICKWORK

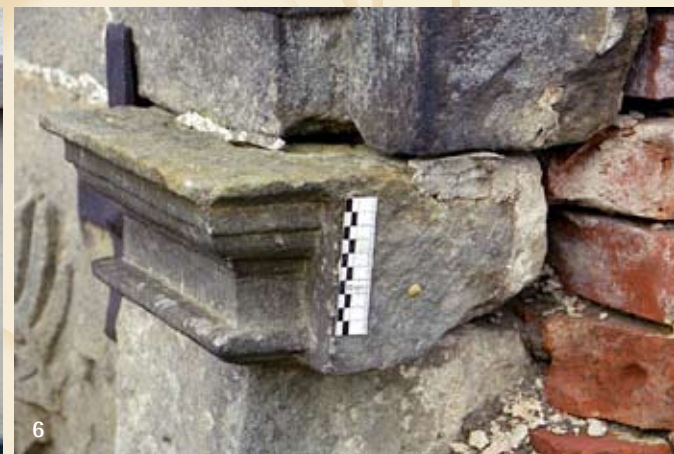
Fig. 6 - Displaced masonry units of the pilaster beside the coat-of-arms relief

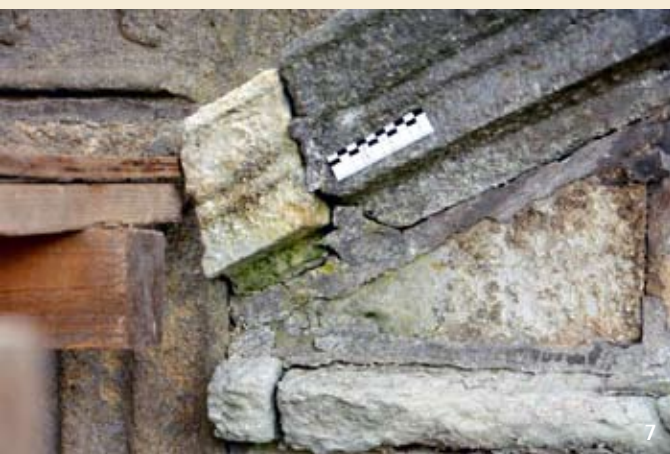
Fig. 7 - Differential erosion and damaged stone graft on the side pediment

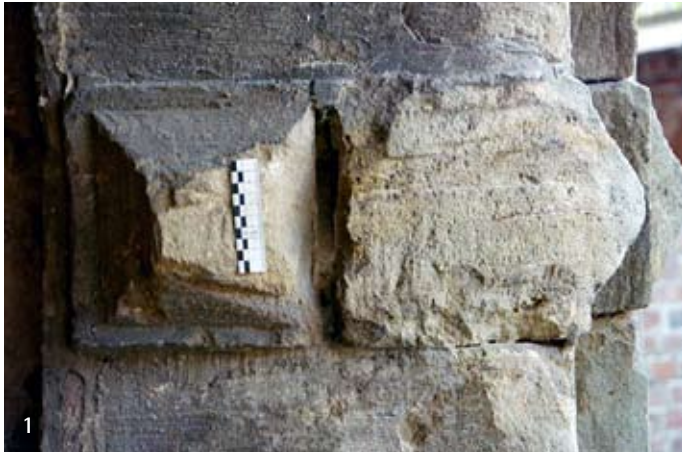
*Fig. 1 - Break outs on the right jamb of the gateway caused by vehicles*

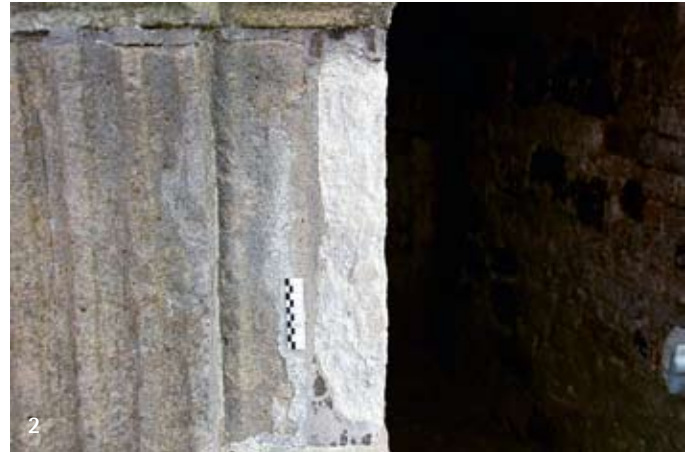
*Fig. 2 - Broken off section of repair material*

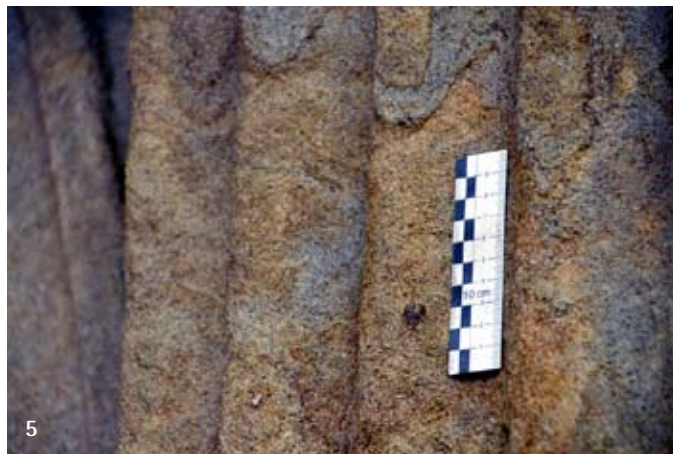
*Fig. 5 - Granular disintegration on the surface of a pilaster section*

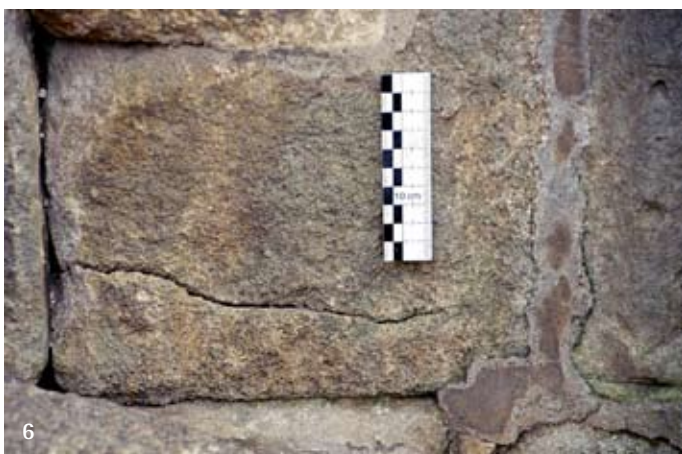
*Fig. 6 - Crack formation*

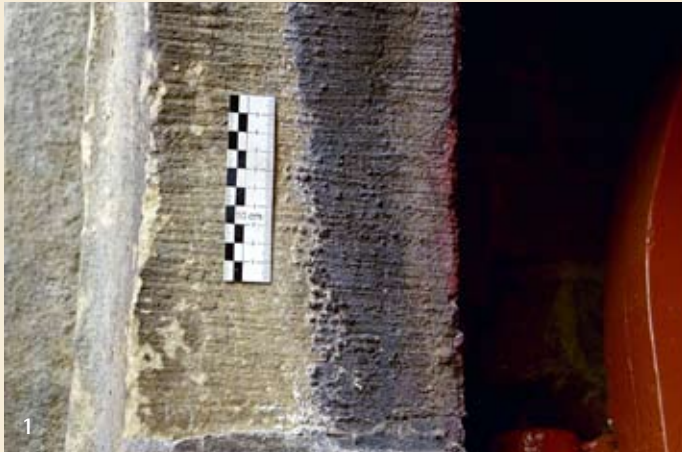
*Fig. 1 - Crust formation on the lower surface of the arch*

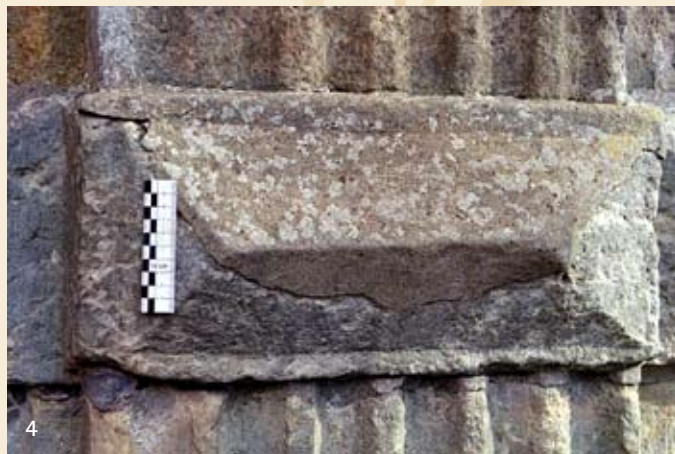
*Fig. 4 - Cracks in mortar repair work*

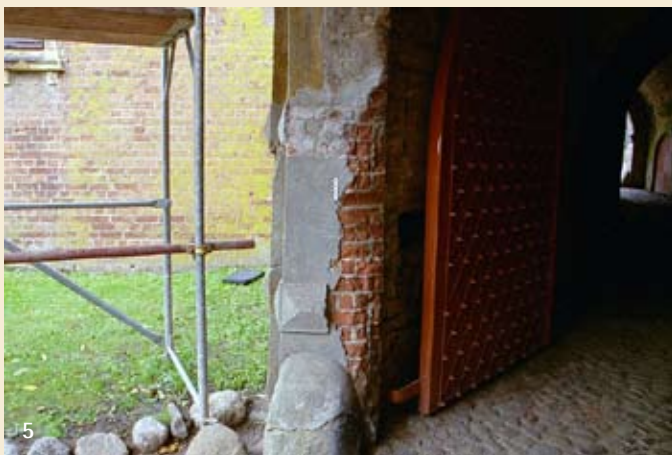
*Fig. 5 - Damaged repair work on the left jamb of the gateway*

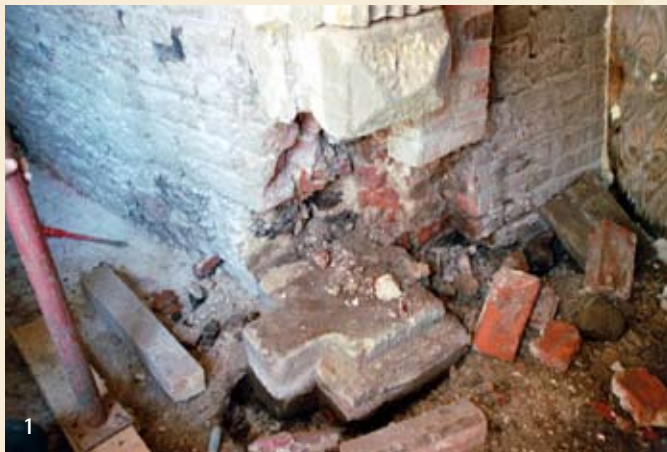
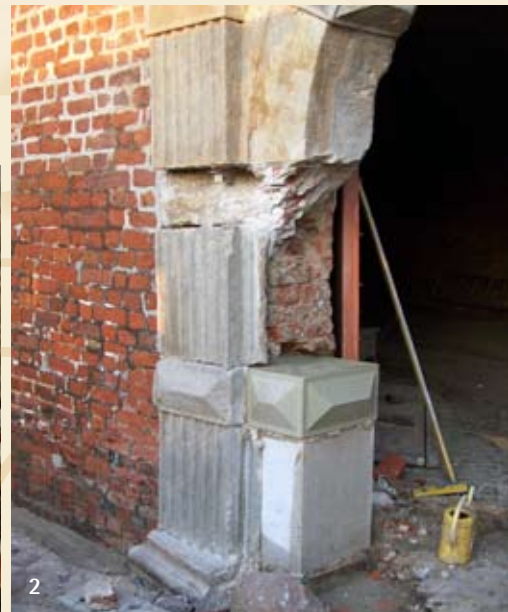
*Figs. 1/2 - Left jamb following the removal of old stone grafts and cement-mortar repairs*

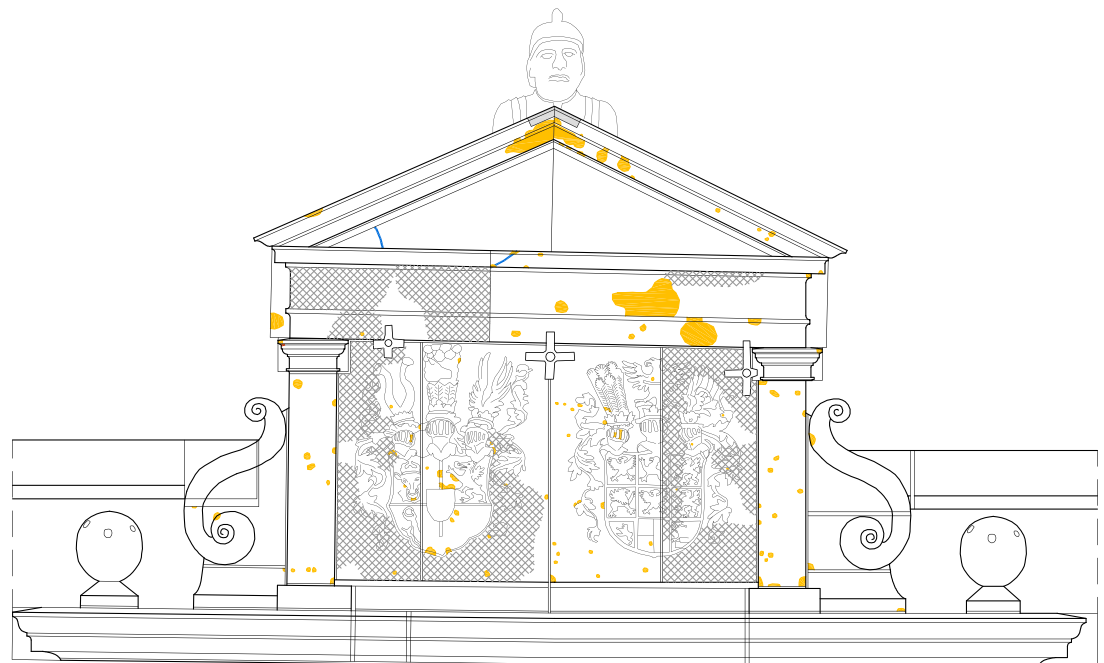
Fig. 4 - Restoration Measure Mapping for the top section of the portal

TYPE OF MAPPING		SITE	OBJECT	STRUCT. ELEMENT/AREA
RESTORATION MEASURE MAPPING		DÖMITZ FORTRESS	SANDSTONE PORTAL	VIEWS
COLOUR	SYMBOL			
		PATCHING WITH STONE REPAIR COMPOUNDS (SAE BINDER)		
		PATCHING WITH STONE REPAIR COMPOUNDS (CALCITIC BINDER)		
		RECEMENTING OF BROKEN PIECES		
		CRACK REPAIR		
		AREAS STRENGTHENED WITH SAE		
		STONE GRAFT
